# Evaluation of a Multi-Kw, High Frequency Transformer for Space Applications

Mary Ellen Roth  
*Lewis Research Center*  
*Cleveland, Ohio*

August 1994

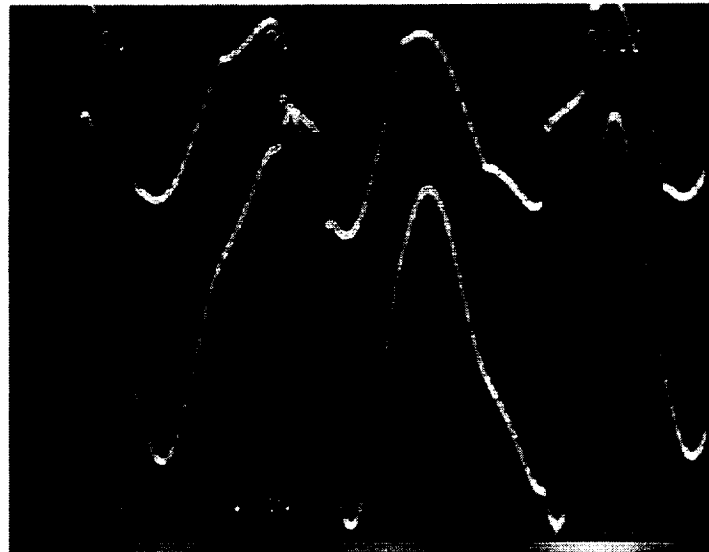
15 Kw power test in atmosphere

$E_p$   
200 V/div

$I_p$   
50 A/div

$E_o$   
500 V/div

$I_s$   
10 A/div

The first failure occurred during testing at 16 kW. There was a problem with distortion of the waveforms. These waveforms are depicted in Figure B.1 of the Appendix. The failure occurred 45 minutes into the test procedure. The maximum temperature at the time was 228° F. The transformer was disassembled and examined to determine the cause of the failure. Examination of the transformer revealed a hole in the two 5 mil sections of Kapton insulation located between the secondary bus bar and the aluminum support plate #8. Figure 3 shows the location and nature of the failure. It was concluded that the breakdown of the Kapton was due to increased electric field strength along the sharp edges of the aluminum support plates. The damaged Kapton was removed and replaced with two 6 mil strips of Mica tape. The sharp edges of plates 7 and 8 were rounded.
